NON-DESTRUCTIVE EXAMINATION OF CORRODED CONCRETE STRUCTURES USING RADIOGRAPHY

K SARAVANAN, S SRINIVASAN, V KAPALI, N U NAYAK, R H SURESH BAPU,
A MADIHAVAMAYANDI, R M KALYANASUNDARAM, N S RENGASWAMY AND K BALAKRISHNAN

Central Electrochemical Research Institute, Karaikudi 630 006, Tamil Nadu, INDIA

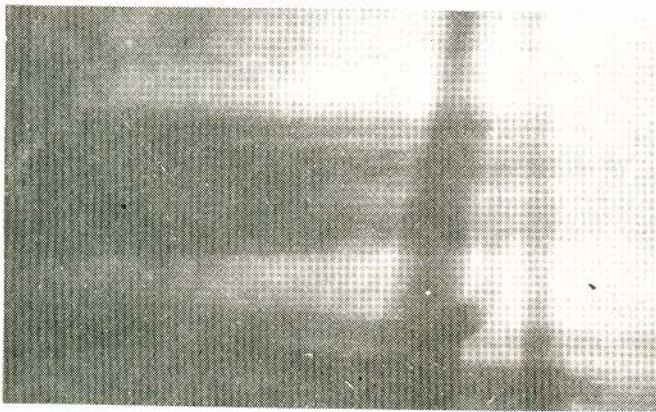
Fig. 3: Positive print of radiograph taken in bridge 1

The site plan of the bridges and the spans radiographed are given in Fig. 1. Fig. 2 represents the cross section of the girder of bridge 1, location of the "Betatron", the film and that of prestressing cable. The optical densities measured on the X-ray films at different locations are presented in Table I. Figs. 3 and 4 are positive prints of the radiographs of the same. It is seen from Fig. 3 that six numbers of vertical non-prestressing steel are identifiable. Two numbers of horizontal reinforcements at the bottom are identifiable. In addition the support hook for the cable sheath is also clearly seen. The corrugated cable sheath is fully distinguishable. It is observed that the prestressing strands are centrally positioned at this region. The cement grout surrounding the strands appears less dense, though it uniformly covers. The cement grout between the strands is also distinguishable.

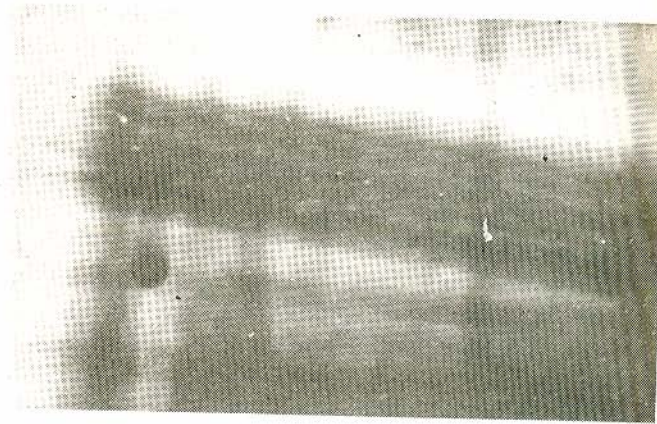
Fig. 4: Positive print of radiograph taken in bridge 2

Seven numbers of non-restressing steel are identifiable in Fig. 4. The untensioned support hook for the cable sheath is also distinguishable. One horizontal reinforcement at the bottom is also seen. The corrugated cable sheath is visible

and is also observed that the prestressing strands are centrally positioned at this location. The cement grout surrounding the strands is also clearly seen. However, the cement grout appears to be less dense at the top portion.
