NON-DESTRUCTIVE EXAMINATION OF CORRODED CONCRETE STRUCTURES USING RADIOGRAPHY

K SARAVANAN, S SRINIVASAN, V KAPALI, N U NAYAK, R H SURESH BAPU,
A MADHAVAMAYANDI, R M KALYANASUNDARAM, N S RENGASWAMY AND K BALAKRISHNAN

Central Electrochemical Research Institute, Karaikudi 630 006, Tamil Nadu. INDIA

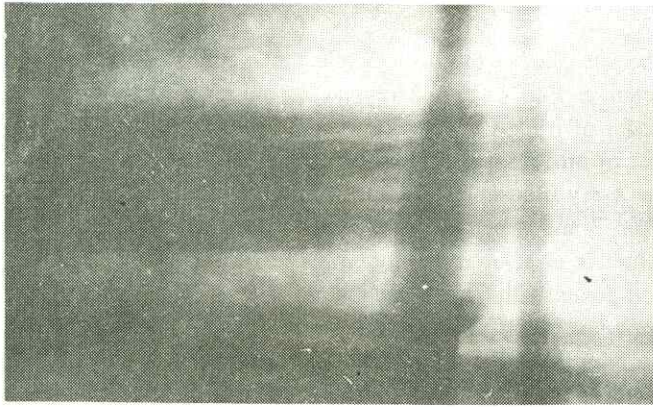
Fig. 3: Positive print of radiograph taken in bridge 1

The site plan of the bridges and the spans radiographed are given in Fig. 1. Fig. 2 represents the cross section of the girder of bridge 1, location of the "Betatron", the film and that of prestressing cable. The optical densities measured on the X-ray films at different locations are presented in Table I. Figs. 3 and 4 are positive prints of the radiographs of the same. It is seen from Fig. 3 that six numbers of vertical non-prestressing steel are identifiable. Two numbers of horizontal reinforcements at the bottom are identifiable. In addition the support hook for the cable sheath is also clearly seen. The corrugated cable sheath is fully distinguishable. It is observed that the prestressing strands are centrally positioned at this region. The cement grout surrounding the strands appears less dense, though it uniformly covers. The cement grout between the strands is also distinguishable.

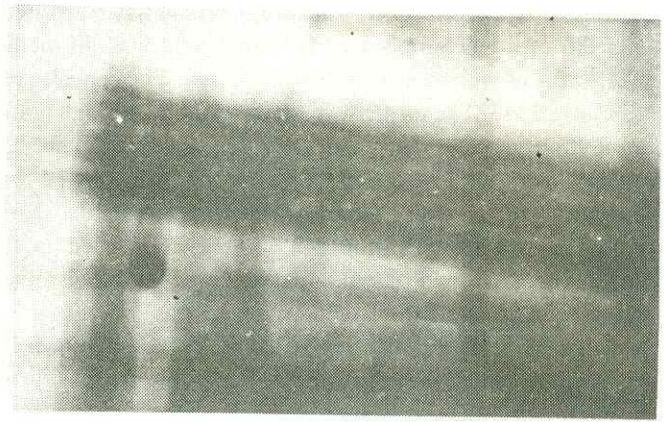
Fig. 4: Positive print of radiograph taken in bridge 2

Seven numbers of non-restressing steel are identifiable in Fig. 4. The untensioned support hook for the cable sheath is also distinguishable. One horizontal reinforcement at the bottom is also seen. The corrugated cable sheath is visible

and is also observed that the prestressing strands are centrally positioned at this location. The cement grout surrounding the strands is also clearly seen. However, the cement grout appears to be less dense at the top portion.
